REHOBOTH CHRISTIAN COLLEGE – KENWICK 2021 ANNUAL COMPLIANCE REPORT MINISTERIAL STATEMENT 780

MARCH 2021

MINISTERIAL STATEMENT 780 2021 ANNUAL COMPLIANCE REPORT

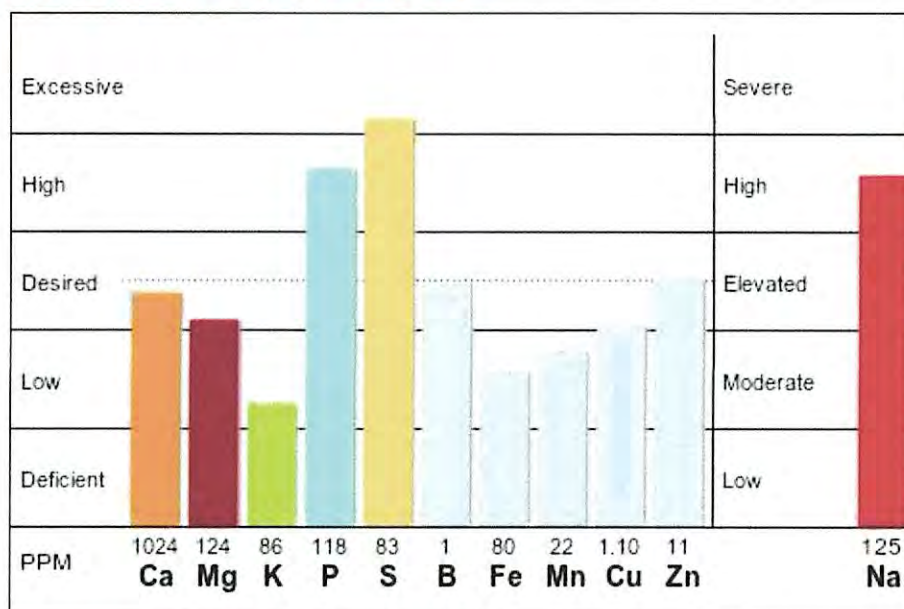
SOIL NUTRIENT STATUS: MAIN OVAL

Organic Matter (humus) 3.5%

pH (H₂O 1:5) 6.8

The Soil Nutrient Analysis has been completed, the results and recommendations based on averages of all samples are as follows;

The level of soil organic matter was adequate within the samples. This indicates that the profile should be able to retain nutrients and moisture for the plants use. To maintain a good level of organic matter continue to apply organic based fertilisers and amendments regularly throughout the year.

On average calcium (Ca) levels in the samples were low. The lack of calcium in the profile could be reducing soil structure and may cause compaction and low porosity. A lack of calcium can also allow a build up of undesirable cations such as sodium. Calcium is a vital nutrient in plant cell strength and development, and low levels can cause the plant to become more susceptible to disease. The cause to a low calcium soil profile could be poor quality irrigation water containing bicarbonates.

These numbers are to correct soil deficiencies only. Nutrient losses such as leaching or plant uptake should be considered when formulating maintenance programs.

Kg per Ha of Calcium deficient	20	Apply a total of 0.5 Kg per 100 m ² of a 38% Ca material over an appropriate number of applications.
Kg per Ha of Magnesium deficient	12	Apply a total of 0.7 Kg per 100 m ² of a 17% Mg material over an appropriate number of applications.
Kg per Ha of Potassium deficient	47	Apply a total of 1.1 Kg per 100 m ² of a 0-0-42 material over an appropriate number of applications.
Kg per Ha of Phosphorus deficient	0

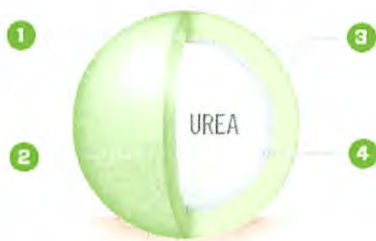
ADVANCED DUAL COATING TECHNOLOGY

XCU is a coated urea product. The outer layers consist of a thin coating of elemental sulphur and polymer wax, which work together to protect the inner polymer coating. This inner layer consists of a cross-linked polymer film that protects the urea granule.

1. Less sulphur coating reduces N lock-off and delivers more N.
2. Coating integrity is maintained during transport, blending, bagging and application.
3. Outer layers consist of a thin coating of elemental sulphur and polymer wax, which work together to protect the inner polymer coating.
4. Inner layer consists of a thin, cross-linked polymer film that encapsulates and protects the urea granule.

The XCU slow-release nitrogen technology used in GTS Sport Turf Fertilisers provides gradual, steady nutritional uptake for up to 10 weeks of plant response.

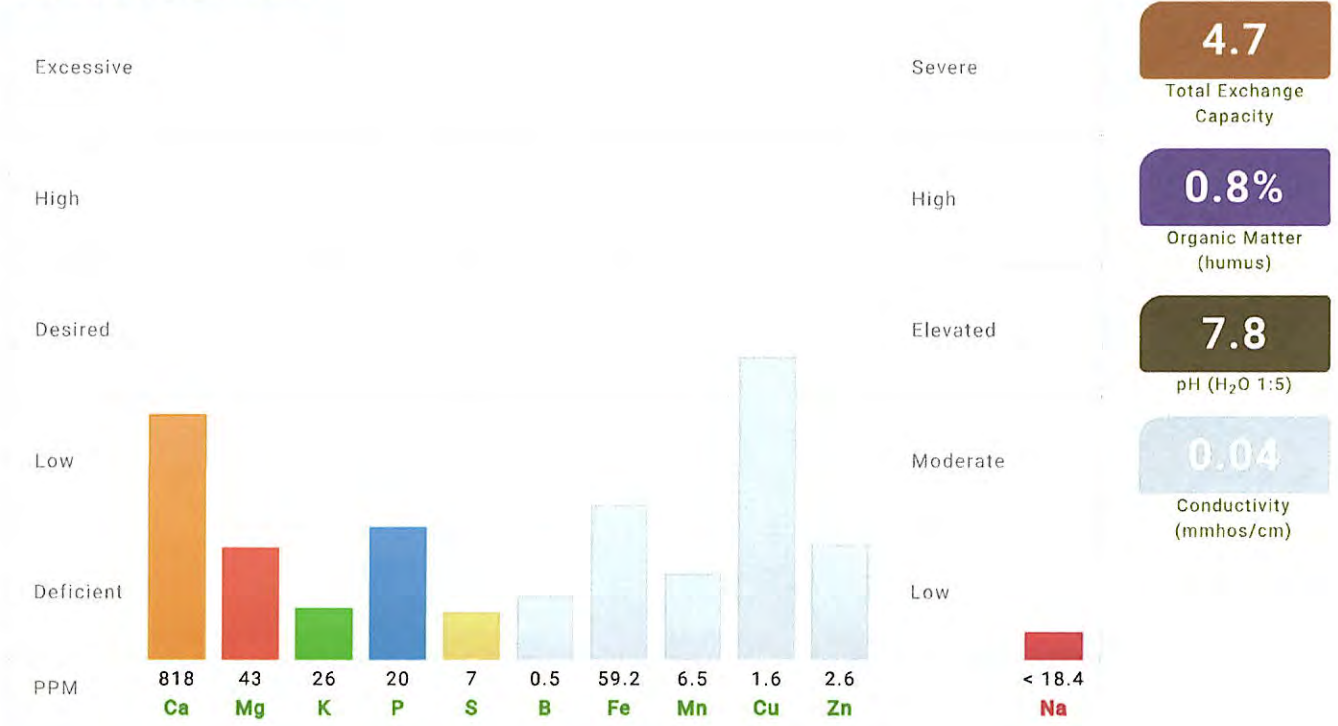
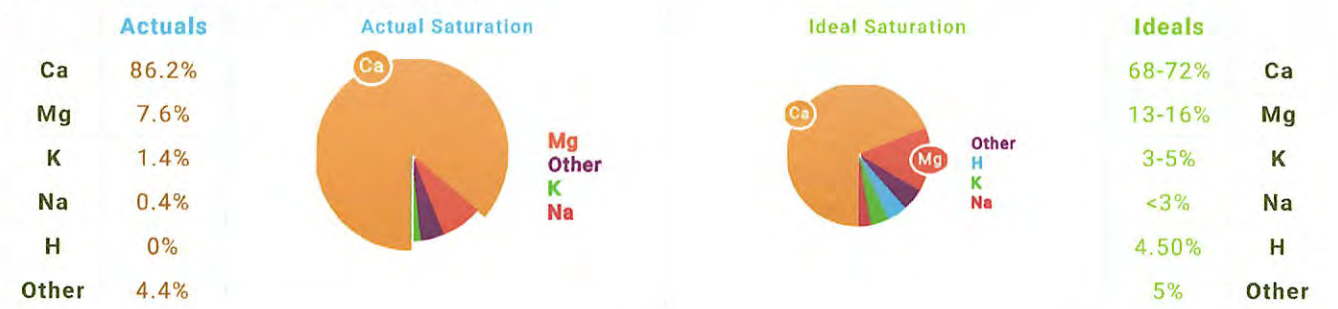
PRIMARY LAWN

Kg per Ha of Calcium deficient	421
Kg per Ha of Magnesium deficient	145
Kg per Ha of Potassium deficient	230
Kg per Ha of Phosphorus deficient	60

Apply a total of **18.30** Kg per 100m² of Tru-Gyp over an appropriate number of applications

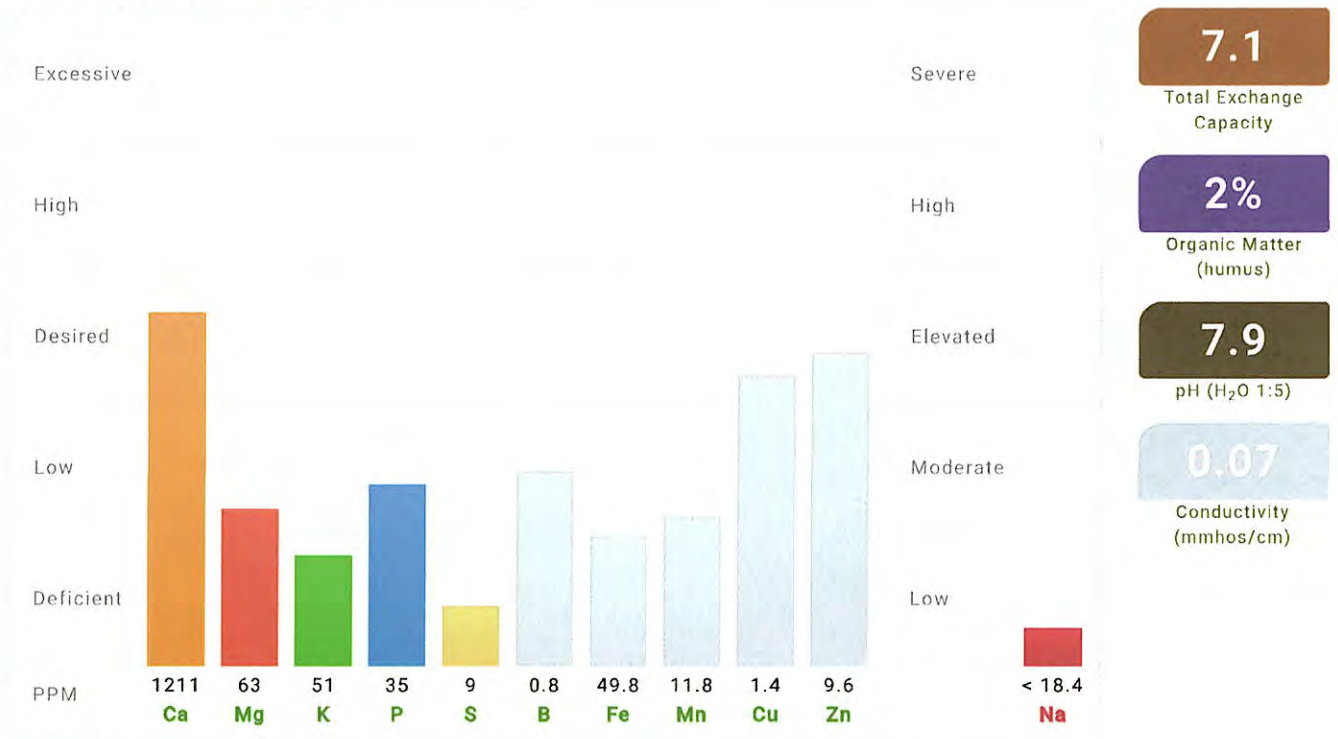
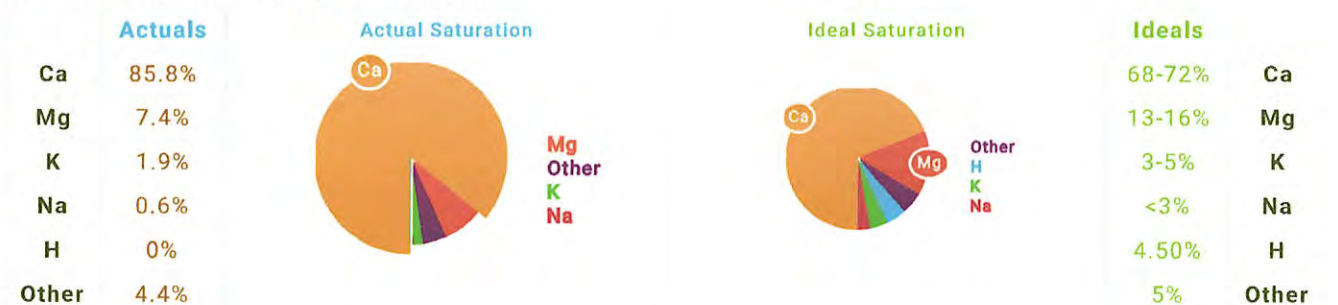
GYM LAWN

Kg per Ha of Calcium deficient	0
Kg per Ha of Magnesium deficient	115
Kg per Ha of Potassium deficient	193
Kg per Ha of Phosphorus deficient	37

Apply a total of **7.19** Kg per 100m² of Soilfix Mg over an appropriate number of applications

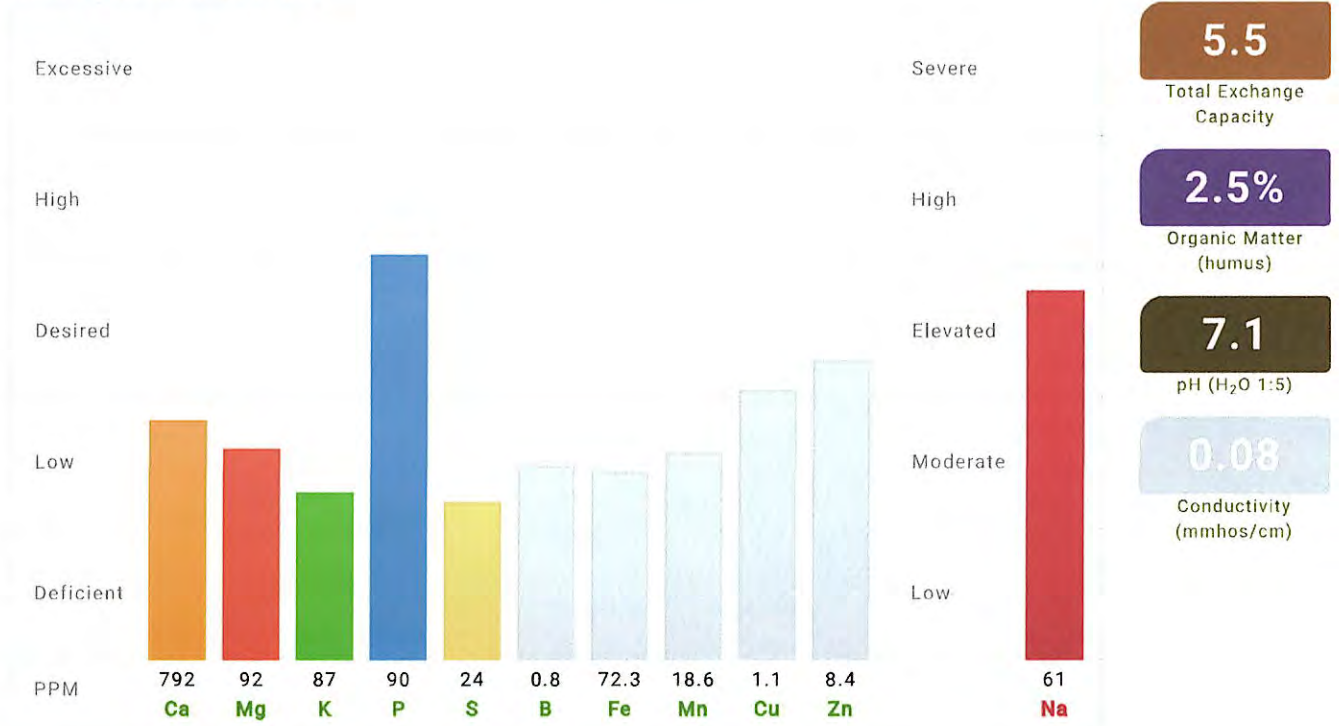
Soil Nutrient Status

Kg per Ha of Calcium deficient	460
Kg per Ha of Magnesium deficient	57
Kg per Ha of Potassium deficient	139
Kg per Ha of Phosphorus deficient	0

Apply a total of **20.00** Kg per 100m² of Granular Gypsum over an appropriate number of applications

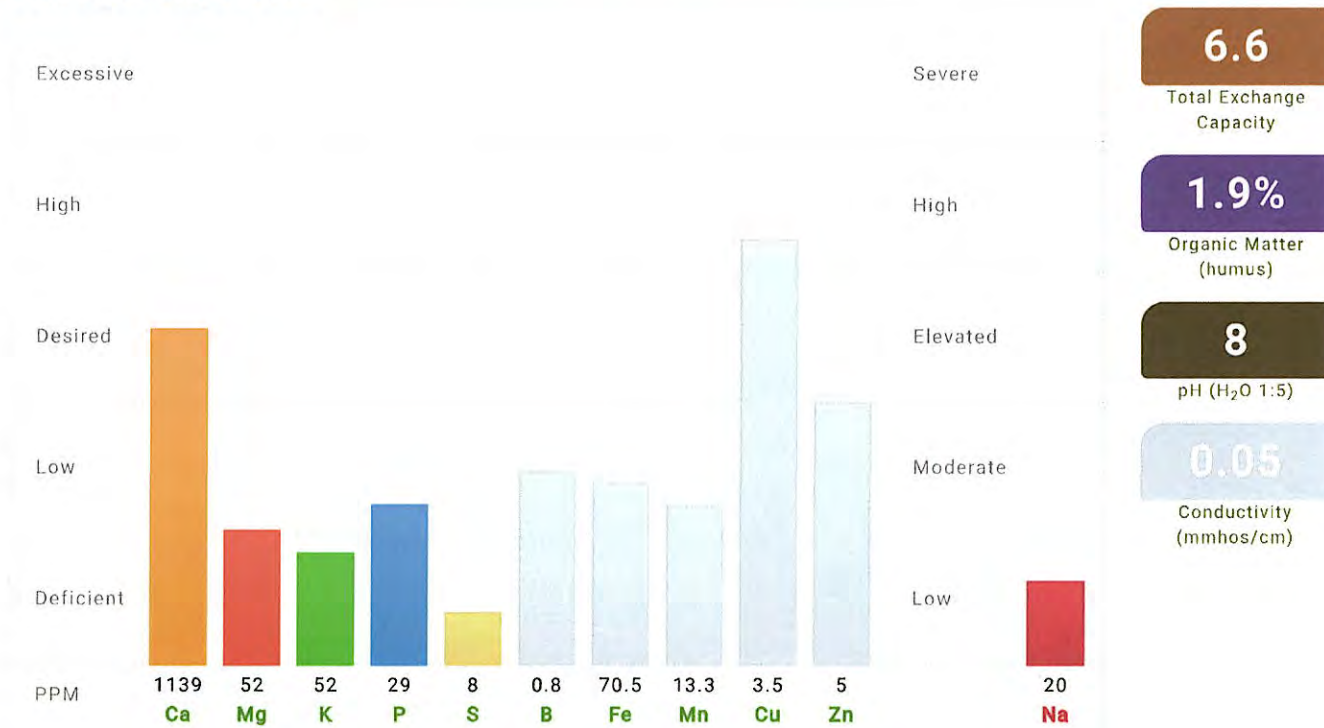
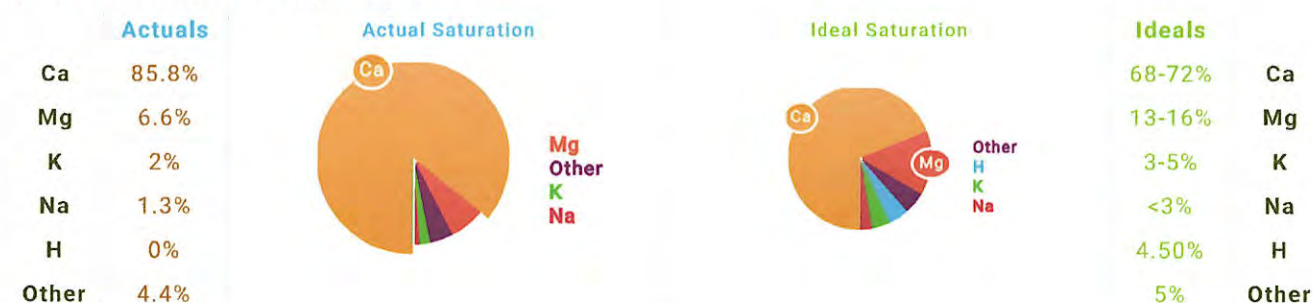
PRIMARY LAWN

Kg per Ha of Calcium deficient 0

Kg per Ha of Magnesium deficient 116

Kg per Ha of Potassium deficient 191

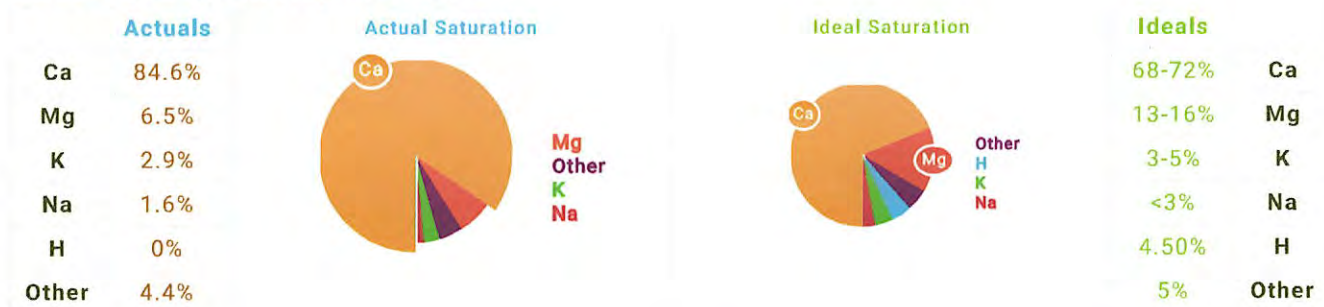
GYM LAWN

Kg per Ha of Calcium deficient 0

Kg per Ha of Magnesium deficient	108
Kg per Ha of Potassium deficient	140
Kg per Ha of Phosphorus deficient	33
